PRE-EXISTING SURFACE SCRATCHES PROMOTING FLAKING OF SHADOW CORROSION ON BWR CLADDING

KARIN CARLING

Ringhals AB

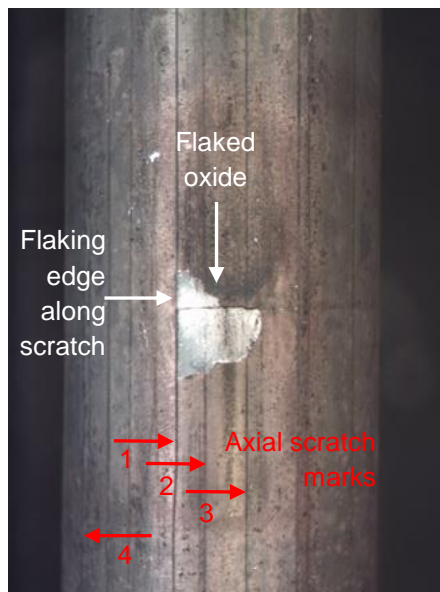
The visual appearance of the fuel rod (photographed in a periscope) at the position selected for the study is shown in Figure 1a. The SEM sample included the three axial scratch marks numbered 1-3 in the area with shadow corrosion; additionally another scratch (scratch 4) approximately 34° circumferentially away from scratch 1 and outside of the shadow corrosion area was also studied. Figure 1b shows an overview in the SEM of the flaked region of the sample. The red arrows indicate the FIB milling positions in the region of the flaked oxide.

Figure 1a. Visual overview of rod with axial scratches and flaked shadow oxide.

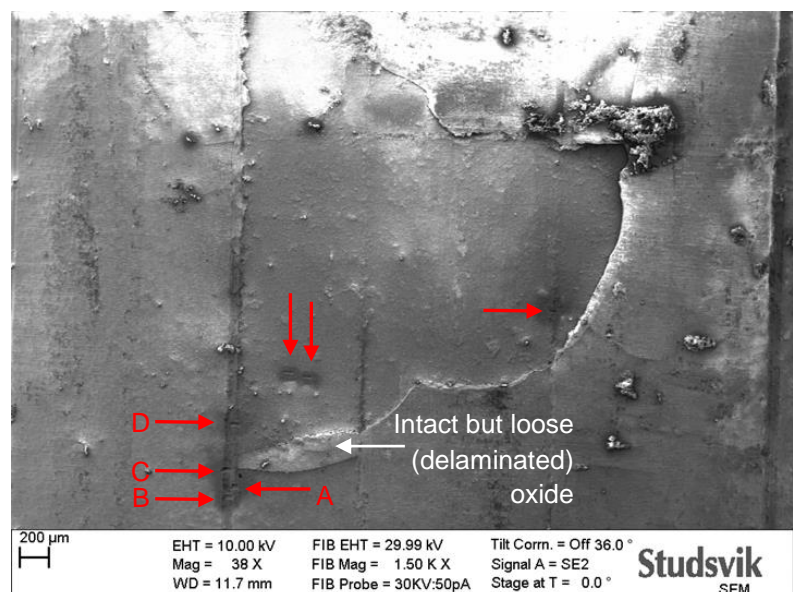
Figure 1b. SEM overview of sample indicating FIB milling cross-section ("ditch") in region with flaked shadow oxide.

Several FIB cross-sections (or "ditches") were milled adjacent to and in the scratch mark on the left hand side of the flaked-off oxide – these are numbered A to D and their positions are shown in Figure 1b. Since this scratch mark delineates the straight left edge of the oxide flake, the FIB ditches were milled out in a direction normal to the direction of the scratch in order to see how the oxide flaking was affected by the scratch mark. Ditches A to C are in the non-spalled region of the shadow oxide.

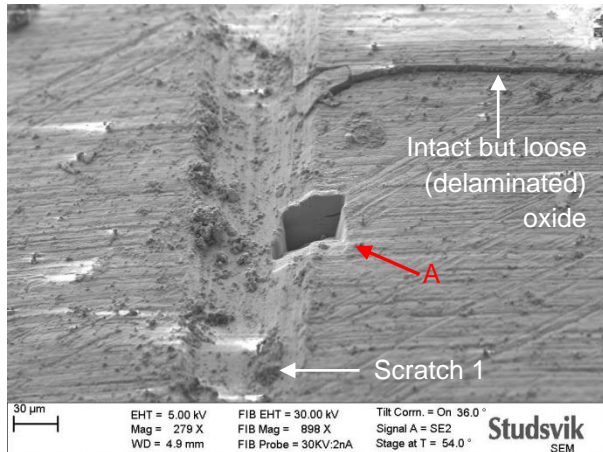
An overview of the scratch mark in the region with non-spalled oxide is shown in Figure 2a, together with the FIB ditch A on the right side of the scratch. The width of the scratch “valley” is approximately 80 μm and since the FIB ditches were limited to a width of about 30 μm it was not possible to have a single ditch extending right across the full width of the scratch valley. In Figure 2b it can be seen that the oxide on the side of the scratch valley is less than half as thick as the oxide just outside the scratch valley. It is also notable that the thicker oxide outside of the scratch valley has cracks parallel to the oxide-metal interface, while the thinner oxide on the side of the valley is essentially free of such cracks.

Figure 2a. Overview of scratch mark 1 and FIB ditch A.

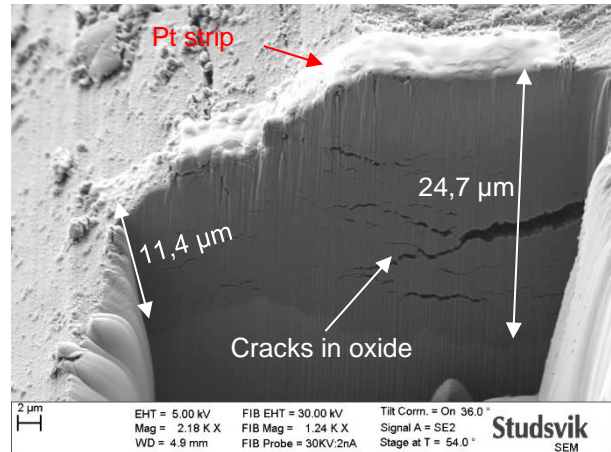
Figure 2b. FIB ditch A, higher magnification.

Delamination-type cracks parallel to the oxide-metal interface were seen in the thicker shadow oxide outside of the scratch region, see Figures 2b and 4b. This type of de-cohesion or delamination crack is frequently seen in shadow oxide, and examples have sometimes been reported in the literature [3]. A previously unpublished example is shown in Figure 6 below, which shows a SEM image of a several mm long longitudinal section through the spacer shadow corrosion region of a different cladding sample. This sample is from a fuel rod with a different spacer design leading to more extensive shadow corrosion than in the cladding sample used for the FIB study. This example shows that a delamination-type crack parallel to the metal-oxide interface can extend over a very great distance without the oxide flaking off, in the absence of cracks in the radial direction penetrating through the oxide layer.

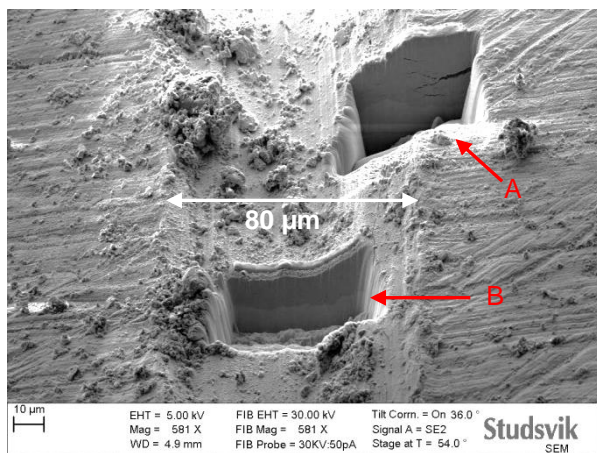
A position in the scratch mark 1 valley was selected for a FIB-milled ditch where cracks were seen emerging to the surface of the oxide layer in a direction parallel to the direction of the scratch. The intention was to see if the cracks emerging from the surface connect with cracks within the oxide layer parallel to the metal-oxide interface, which could explain the flaking.

Figure 3a. Surface of scratch mark 1 valley showing positions of FIB ditches A and B.

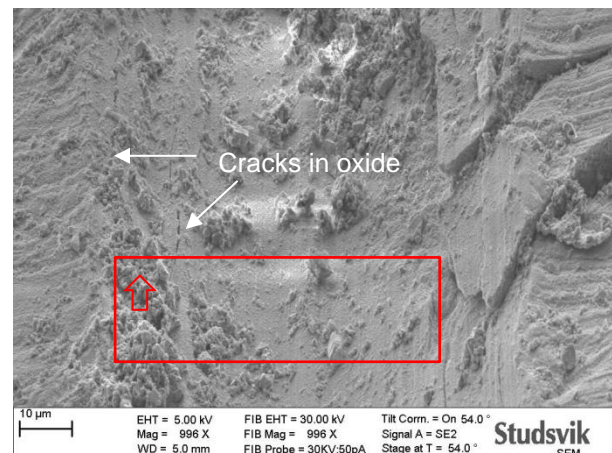
Figure 3b. Surface of scratch mark 1 valley before milling FIB ditch C. Arrow shows viewing direction in Figure 4a.

Figure 3b shows the surface of the scratch valley before milling the FIB ditch C (the position of ditch C is shown in the red rectangle). Figure 4a shows the FIB ditch C cross-section across almost the entire width of the scratch valley. The left half of this cross-section was milled a bit deeper and further to the left, to surface C' seen in Figure 4b which shows the

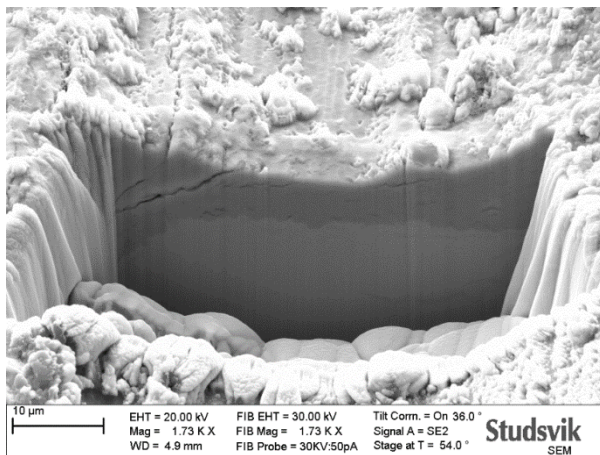
cross-section at the left side of the scratch valley, viewed from the direction shown by the red arrow in Figure 3b. In Figures 4a and 4b it can be seen that the cracks parallel to the direction of the scratch mark, which were seen emerging from the surface of the oxide prior to the FIB milling (shown by white arrows in Figure 3b), penetrate some way into the oxide layer in a direction normal to the surface (cracks 1 and 3 in Figure 4b). As seen in the cross-section, the oxide in the bottom (central part) of the scratch valley is far thinner (about 5 μm thick) than just outside the scratch (about 24 μm thick). A delamination-type crack parallel to the oxide-metal interface typically seen in the shadow oxide outside of the scratch region, is indicated as crack 2 in Figure 3b. This crack follows at roughly the same distance from the oxide-metal interface until almost reaching the surface where the oxide layer is thinnest in the central part of the valley.

Figure 4a. FIB ditch **C** cross-section across scratch mark 1 valley.

The emergence of the delamination crack (crack 2) at the surface where the oxide thins, as well as the presence of long axial cracks vertically into the oxide layer (cracks 1 and 3) are considered the most important contributors to the flaking of the shadow oxide along the surface scratches.

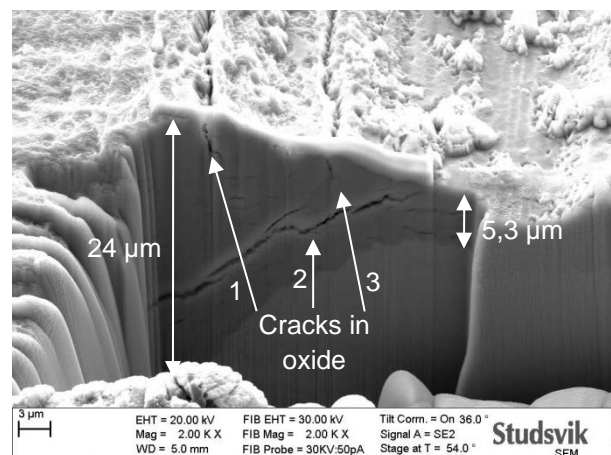
Figure 4b. Detail of FIB cross-section **C'**, left side with crack emerging to oxide surface.

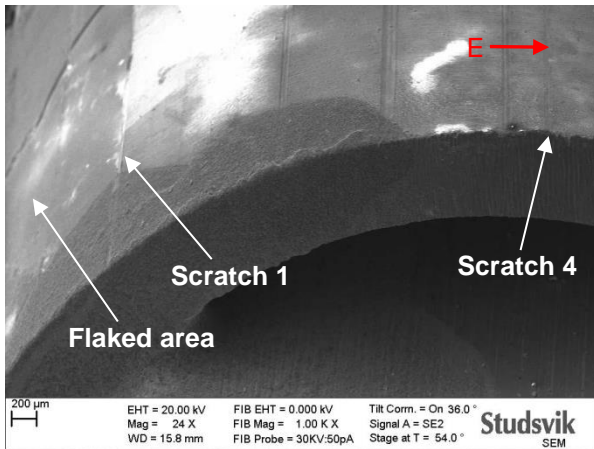
The remaining question to be answered was why similar oxide layer flaking, with the edges of the flakes coinciding with the surface scratches, is not seen outside of the shadow corrosion region. In order to address this question, an additional FIB cross-section was milled across a surface scratch on the same cladding sample, but outside of the shadow corrosion area. The SEM sample only consisted of a half-ring of cladding, so the furthest position from the shadow oxide region practical for examination was at a scratch roughly 34° away in the circumferential direction from scratch 1, as indicated in Figure 1a. The position of the new FIB ditch E is shown in Figure 5a.

Figure 5a. Position of FIB ditch E outside of the shadow corrosion area.

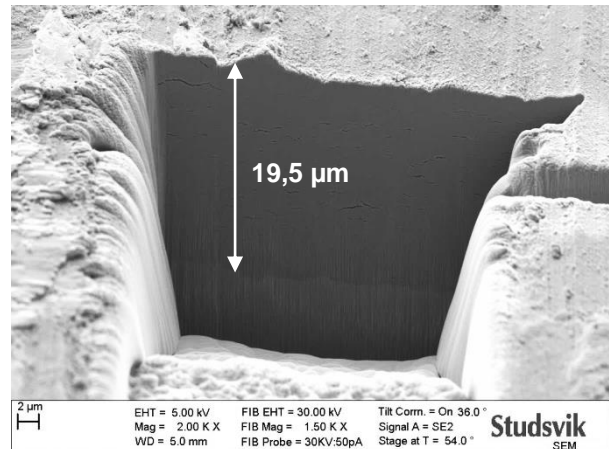
Figure 5b shows the FIB ditch C cross-section across almost the entire width of the scratch valley. The following features of the oxide in this cross-section are immediately seen to differ from the appearance of the oxide in the scratch valleys within the shadow corrosion area:

- The oxide layer has a uniform thickness and is relatively thick (about 20 μm) right across the bottom of the scratch valley. This oxide thickness corresponds roughly to the general oxide thickness measured on the cladding outside of the shadow corrosion position.
- The oxide appears to be dense, with few visible cracks, none of which are large.
- These small, short cracks are predominantly in the direction parallel to the metal-oxide interface but are fairly randomly distributed in the thickness direction.
- There is no single long delamination-type crack as seen in the other sections.

- There are no vertical cracks parallel to the scratch direction that emerge from the oxide outer surface. (In fact, no vertical cracks are seen at all).

Figure 5b. FIB ditch E. Cross-section in middle of scratch 4 valley.

The very different appearance/morphology of the cracks in the oxide in this scratch valley, compared to those observed in the scratch in the area with shadow corrosion, appears to explain why no oxide flaking was seen in connection to scratches outside the shadow corrosion area.

Unlike the case for the scratch in the shadow corrosion region, the cross-section through a similar surface scratch outside the area that experienced shadow corrosion had a uniform oxide thickness across the entire scratch valley (Figure 5b), of the same thickness as the surrounding oxide layer outside the scratch. Neither delamination-type cracks or longitudinal axial-radial cracks along the length of the scratch were seen. Thus neither of the types of cracks believed to be responsible for the flaking along scratches inside the shadow corrosion region were observed, and the thinning of the oxide layer in the scratch did not occur either. Therefore none of the preconditions for flaking were present, which accounts for the fact that oxide flaking coincident with surface scratches has not been observed for any other forms of oxide than shadow corrosion.

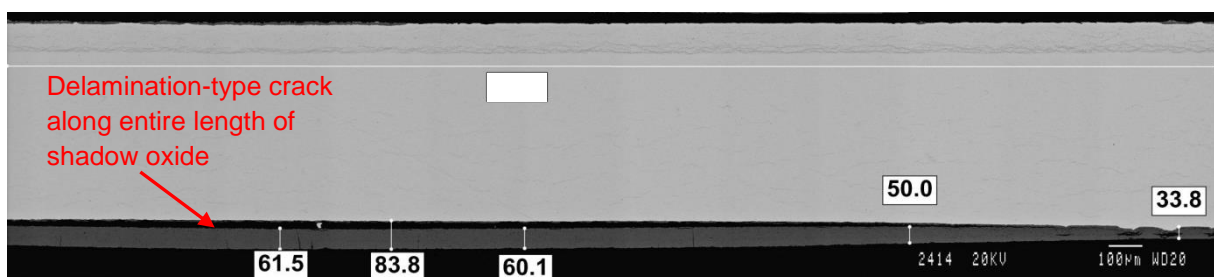
Figure 6. Longitudinal section through spacer shadow oxide region of a different cladding sample, showing delamination-type crack over an extensive distance. Markers indicate total distance from metal to the oxide outer surface including the crack width.

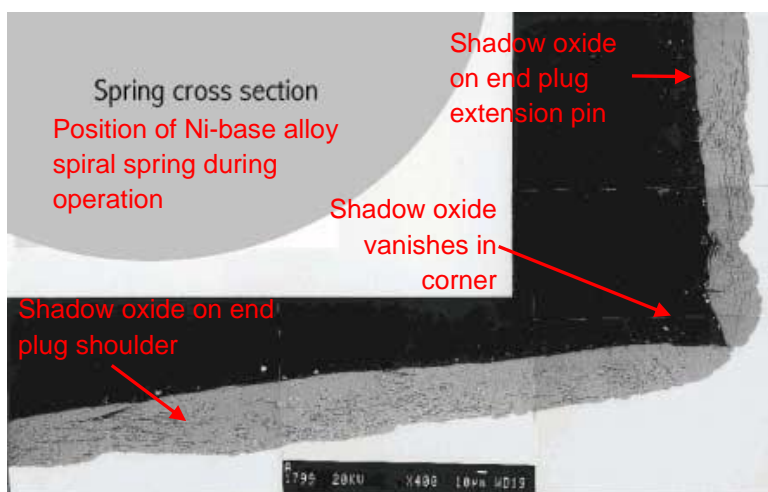
In support of the hypothesis that shadow corrosion is in fact a form of galvanic corrosion, it has been pointed out that the electric field strength approaches zero at a corner of a conductor pointing away from an external electrode [4]. It was experimentally observed that the shadow corrosion oxide fell away to zero at the corner between the narrow diameter pin and the flat shoulder of the Zircaloy end plug of a BWR rod (where the pin is enclosed in a Ni-base alloy spiral spring), as seen in Figure 7. The spring, having a higher corrosion potential, is the external electrode in this case. Since the electric field is zero at the corner, the galvanic current density vanishes at this point. At all other locations the difference in corrosion potential between the two metals gives rise to a non-zero electric field (assuming the two metals are galvanically coupled).

Figure 7. Section through the top end plug of a BWR fuel rod with a pin extension that fits within a spiral Ni-base alloy spring (from reference 4).
