# POOLSIDE INSPECTIONS AT LOVIISA NPP

I. LEHTINEN

Loviisa NPP, Fortum Power and Heat Ltd  
POB 100, FI-00048 Fortum, Finland

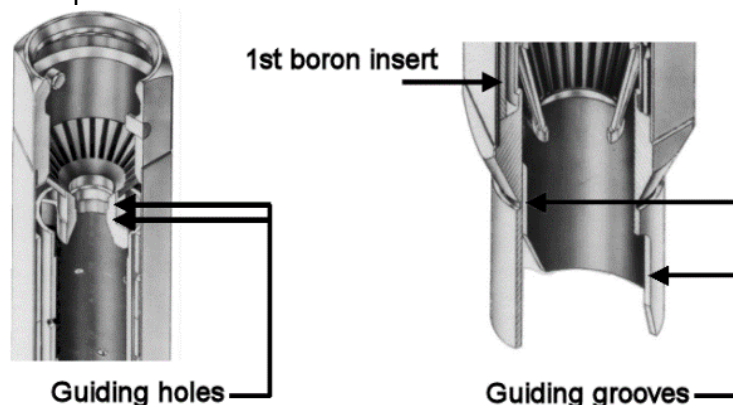
Fig 1. Critical surfaces and structures of a VVER-440 absorber element.

Fig. 1 shows the location of the lowermost boron insert, the guide holes and the guide grooves that are critical for the service life of an absorber. These locations are inspected during every inspection campaign. The continued use of an absorber is approved, if there is no risk that the absorber will exceed its mechanical specifications during the next three years of operation. The assessment is done by extrapolating the measured values using the maximum measured wear rates. No swelling of the lowermost boron insert has been detected and thus extrapolation is not used for the deformation values.

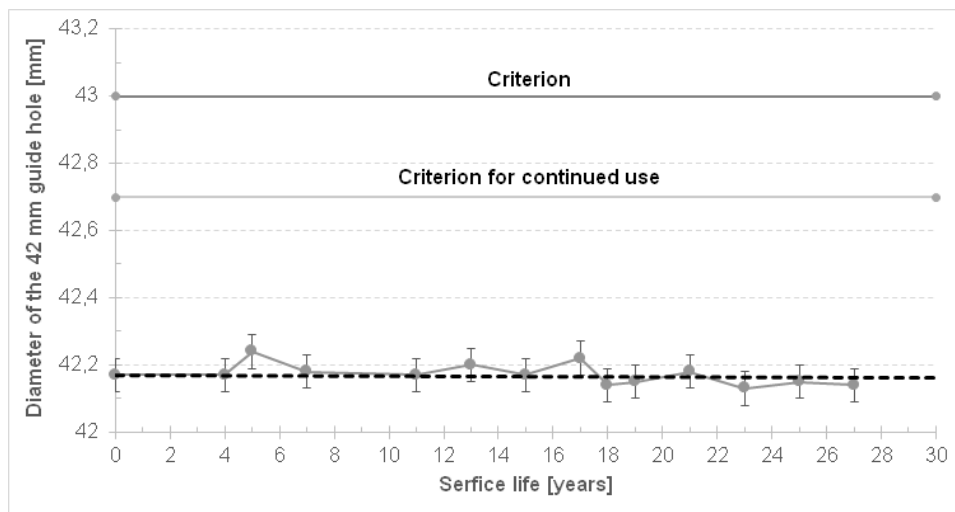
Fig. 2. Combined Loviisa-1 and -2 results of absorber inspection campaigns 1993-2016.

Fig. 2 shows the combined guide hole measurement results of Loviisa-1 and Loviisa-2 absorbers from inspection campaigns since 1989. Although the both guide holes (diameters 42 and 46 mm) are measured, only the results from 42 mm hole are used as a criterion for continued use. This is because the structure of the control rod mechanism is such, that when the 42 mm hole eventually starts to wear, the 46 mm guide hole cannot wear at any different rate from that point forward. Since the guide hole measurements are done manually using a dial gauge, each measurement is repeated twice, and the diameter is measured from three points, each point roughly 120 degrees apart from each other. Furthermore, each guide hole is measured by at least two persons. Based on the linear estimate (Fig. 2), the 42 mm diameter guide hole has not worn at all.

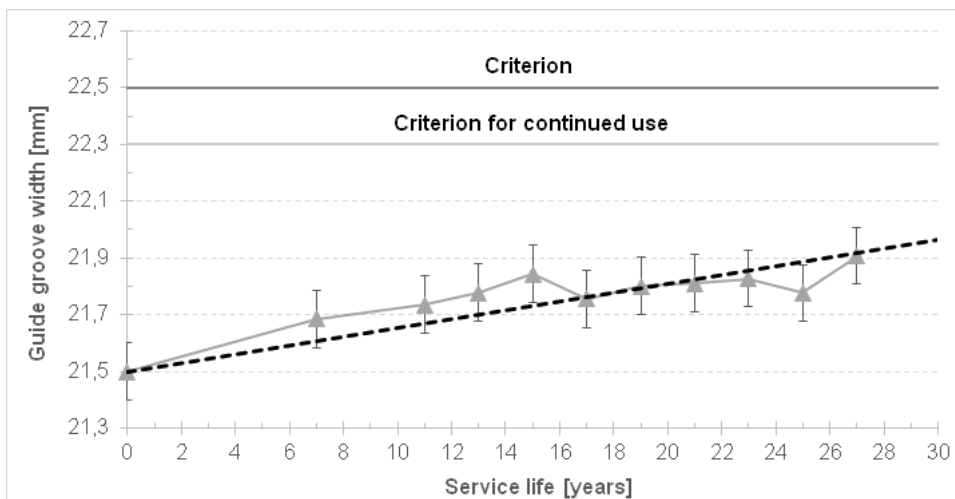
Fig. 3. Maximum wear of Loviisa-1 and -2 absorber tailpiece guide grooves.

Fig. 3 shows the combined guide groove measurement results of Loviisa-1 and Loviisa-2 absorbers from inspection campaigns since 1989. The two guide grooves at the absorber tailpiece control how much it is possible for the absorber to turn around its vertical axis. If the absorber turns vertically more than few degrees, it will touch the adjacent fuel assemblies and there is a risk that the control rod mechanism doesn't work properly. Luckily the groove surface with least wear controls the amount the absorber is able to turn and thus we can measure only the change in the guide groove width. This is easier and more conservative measurement than measuring the wear of each contact point between guide grooves and fuel follower element lifting pins. Based on the linear estimate (Fig. 3), the guide groove wear can be expected to start to limit the service life only after 51 years of use.

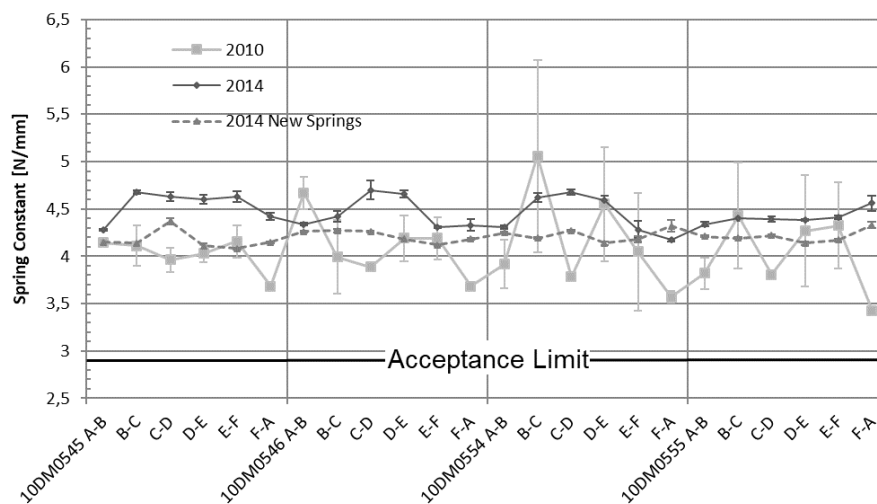
Fig. 4. Results of the spring constant measurements of four Loviisa-2 shielding elements

Fig. 4 shows a comparison of the 2010 and 2014 spring force measurement results for the four Loviisa-2 shielding elements in the inspection program. The graph includes the new (unused) spare spring packages also. The spare packages were used to replace the old packages that had reached their service life limit, eight years. The error bars in the 2010 data are much larger, because the measurements were done using different (old) measuring device. Based on Fig. 3 it is clear that 0, 4 and 8 cycles irradiated spring packages all perform similarly from the spring force point of view. However, during the test run it can be seen, that the used spring packages do not move as smoothly as the new ones.

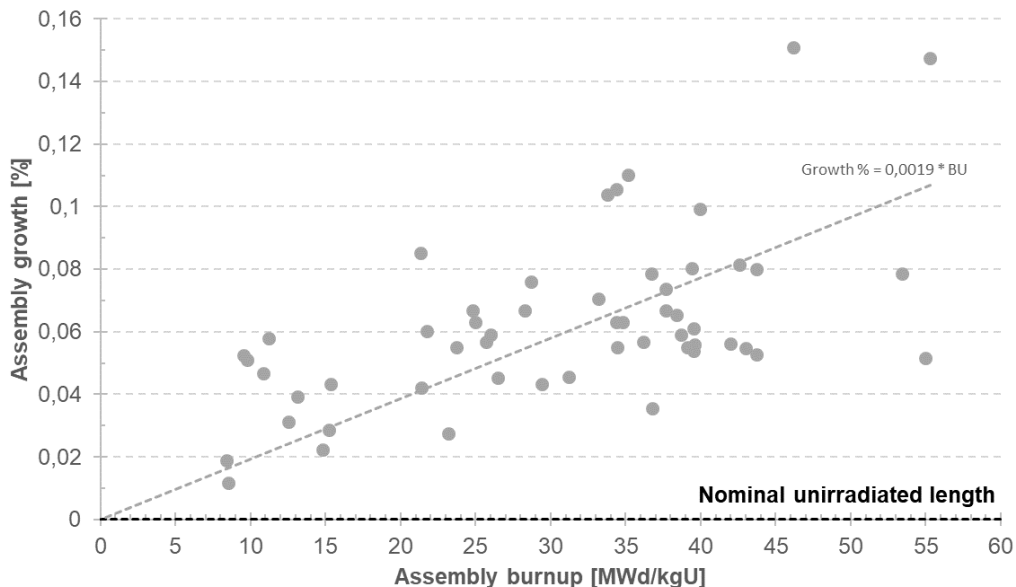
Fig. 5. Assembly irradiation growth relative to the nominal unirradiated length.

Typical measurement campaign is started by measuring the assembly dimensions. Fig. 5 demonstrates the measured irradiation growth occurring in Loviisa NPP fuel assemblies. Since the assemblies are only a bit over 3 meters in length, the assembly bow and twist are minimal. A typical assembly bow is 1-2 mm and twist less than a degree.

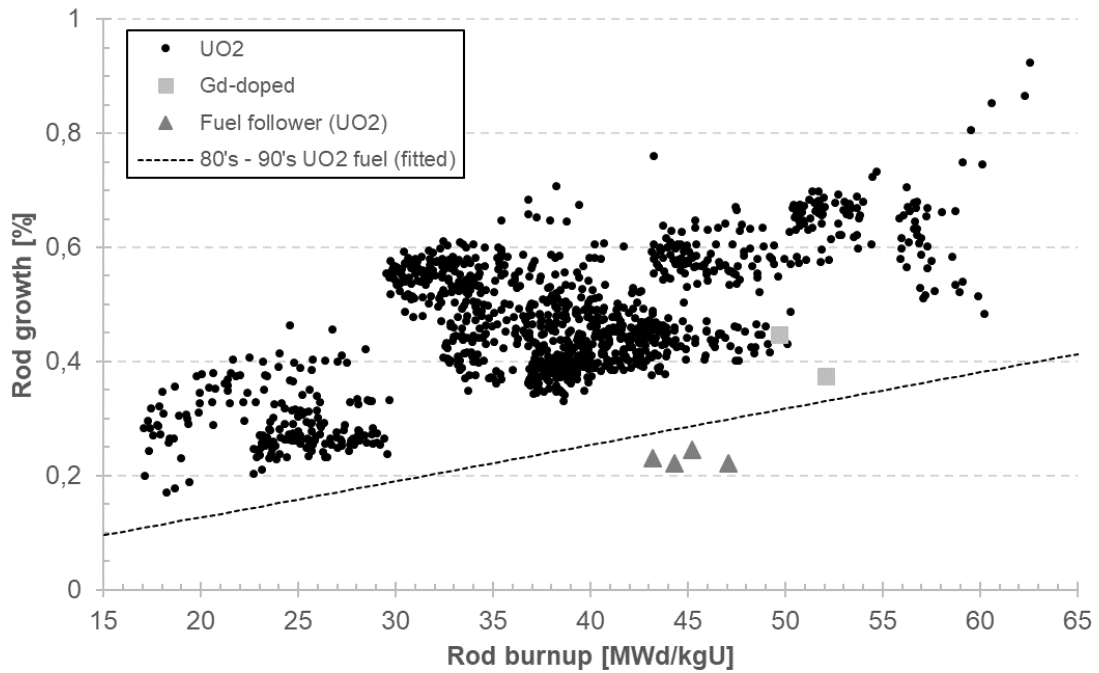
Fig. 6. Rod irradiation growth relative to the nominal unirradiated length.

When the rod bundle inspections are done, single rods are then removed one by one from the assembly and inspected individually. Fig. 6 demonstrates the rod irradiation growth occurring in different fuel types used in Loviisa NPP. The results include both E110 and Zircaloy-4 cladding. In addition to the rod length measurements, rod profilometry and gamma measurements are done to the detached rods. Fission gas releases (FGR) are estimated from the gamma measurements using modified (VTT) version of the LADAKH code [6]. Fig. 7 contains recent FGR estimates and also the results from the Studsvik 2003 direct measurements (by puncturing). Studsvik 2018 results are not yet available.
