# END OF LIFE INSPECTION OF FUEL THAT HAD EXPERIENCED TRANSIENT DRYOUT IN FORSMARK 2

ANNA ASPMAN

DAVID SCHRIRE

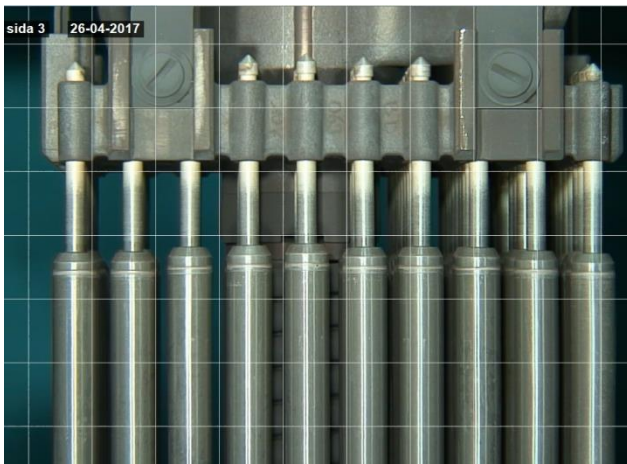
Very little differential fuel rod growth was observed between the peripheral rods along each side of the fuel bundle, see examples in Figure 5.1 (side 3 away from control blade) and Figure 5.4 (side 4 adjacent to control blade). Since the fuel rods are all in contact with the lower tie plate (see Figure 5.2 and Figure 5.3) the difference seen in the top shoulder of the rods also reflect differences in the total rod length.

Since the camera pan was set to zero (angle of view directly normal to the side of the bundle), it could also be checked that none of the fuel rods in the row interior to the peripheral row stuck up above the shoulders of the peripheral rods. The rod identified as that experiencing the peak cladding temperature in the transient dryout was rod h2, in a semi-peripheral row. As can be seen in Figure 5.4 this rod was essentially the same length as its neighbours and thus did not display any unusual growth compared to other fuel rods less affected (or not at all affected) by the transient dryout event. The small differences in length of the peripheral rods essentially followed their differences in burnup (or lifetime averaged power).

Figure 5.1 Side 3 top of bundle.

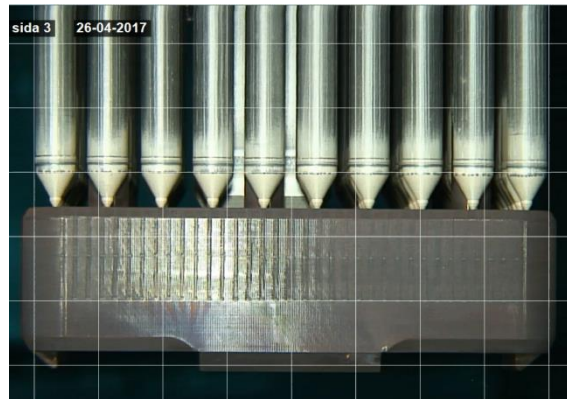
Figure 5.2 Side 3 bottom of bundle (all rods resting on lower tie plate)

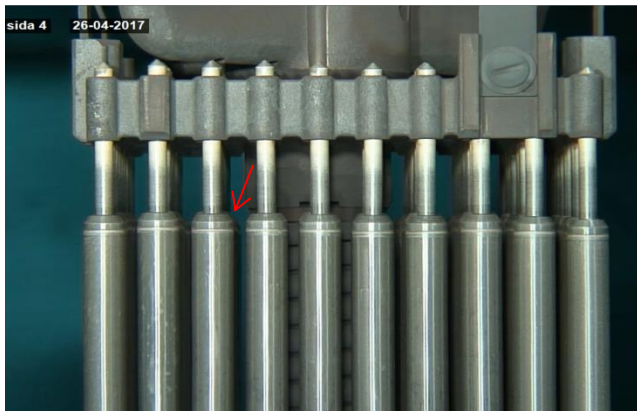
Figure 5.4 Side 4 top of bundle. The limiting rod h2 is in the second row as shown by the arrow.

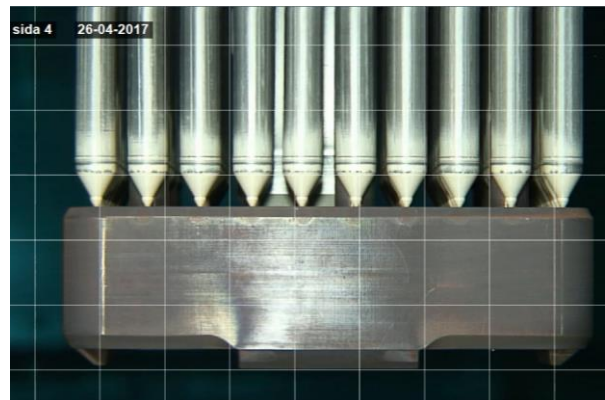
Figure 5.3 Side 4 bottom of bundle (all rods resting on lower tie plate)

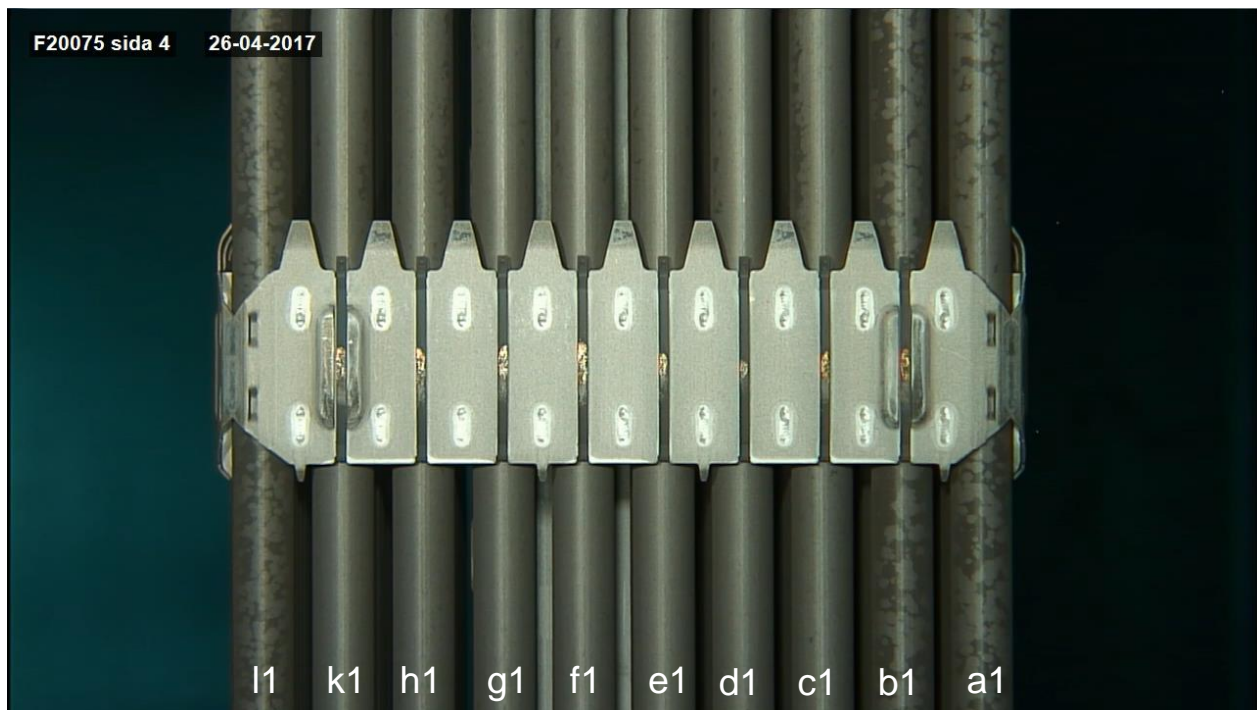
Figure 5.5 Bundle F20075, spacer 7, side 4.

The patchy oxide appearance on the fuel rods near the corners of the bundle (rods a1, b1 and l1 in Figure 5.5) is due to the non-uniform transition from a thin darker oxide layer to a slightly thicker, lighter coloured oxide layer. In the other fuel rods with more uniform colouring most or all of the cladding has an oxide covering that is thicker than the transition thickness where the colour change occurs. These differences in visual appearance are not related to the transient dryout early in life.
