FRM II: REPLACEMENT OF THIMBLES MADE FROM ALMG3 (EN AW-5754) FORMING A BARRIER BETWEEN HEAVY AND LIGHT WATER AFTER DETECTION OF CORROSION

Technische Universität München, Forschungsneutronenquelle Heinz Maier-Leibnitz (FRM II)

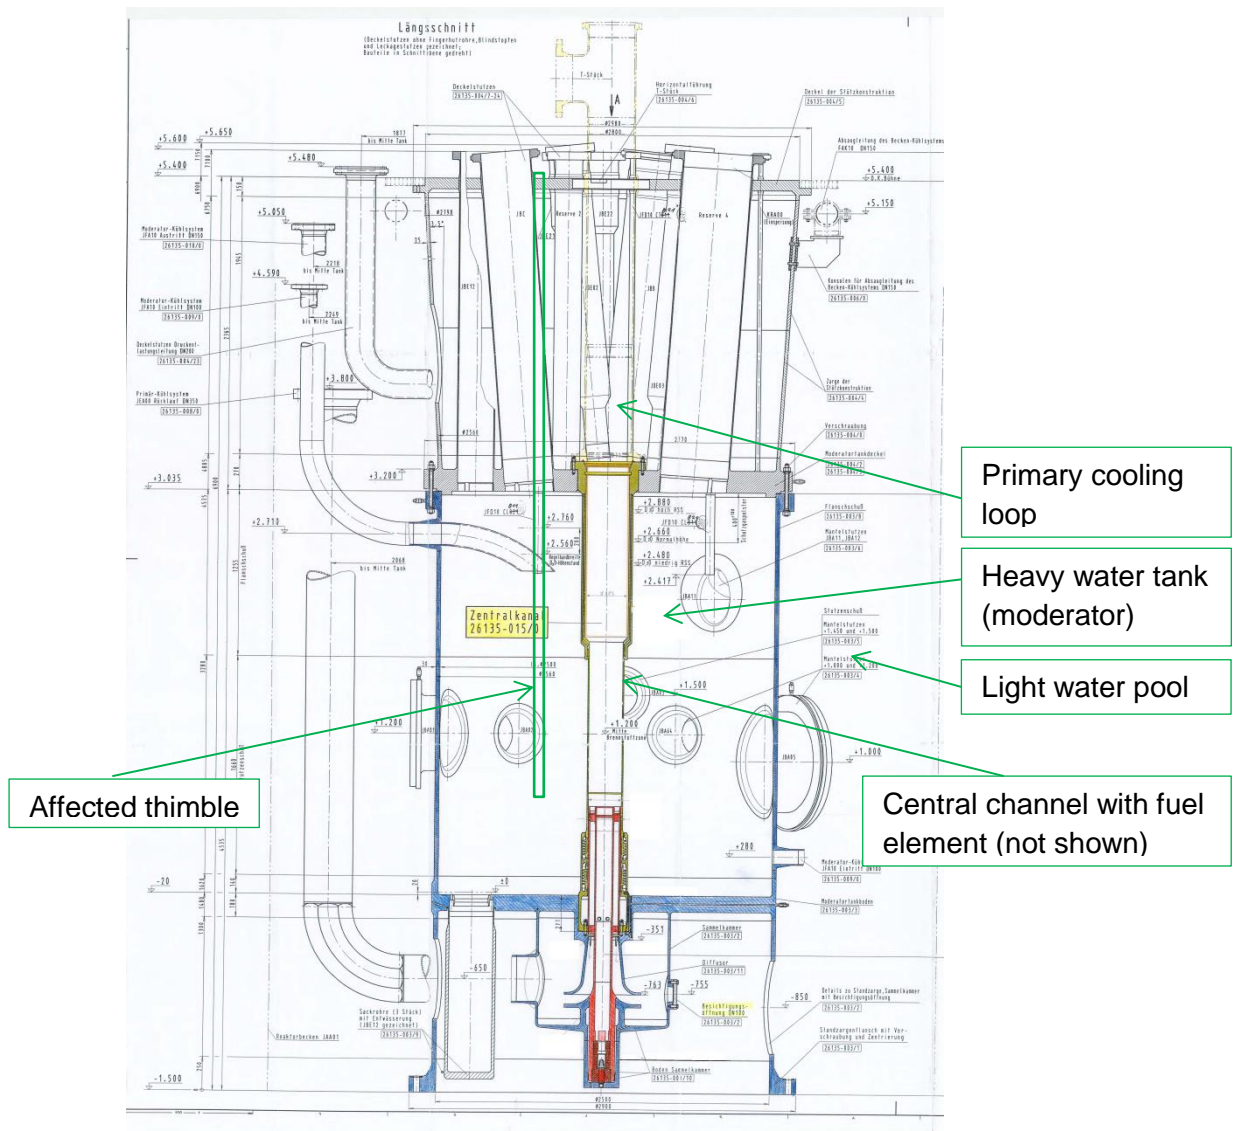
Fig. 1: The FRM II Moderator tank, surrounded by light water. The affected thimble is indicated in its approximate position and scale.

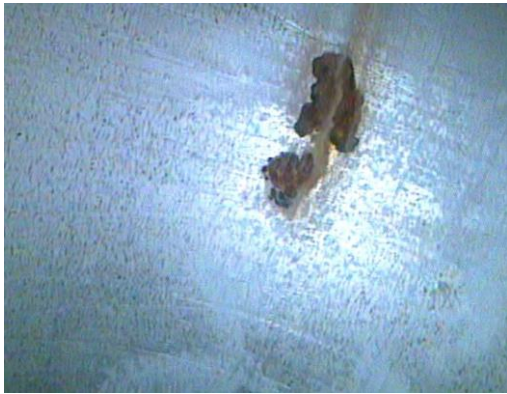
During a maintenance break with low level of water in the reactor pool a slight increase of the ^3H concentration in the reactor hall, far below any release limits, was detected. Soon it became clear that it had to be related to the heavy water (D_2O), the only significant ^3H source available. Since no immediate detailed cause could be determined the water level in the pool was raised which stopped the ^3H emission. Further investigation soon revealed a small concentration of ^3H also in the pool water. It was estimated from the ^3H concentration that a total amount of some hundred cc of D_2O had contaminated the H_2O . Looking at the phenomenon in even more detail a thimble housing a thermocouple was identified as the main ^3H source. An endoscopic inspection of the thimble was carried out. Several spots of a few square millimetres in size that resembled ironoxide in colour were discovered, a finding not to be explained straight forwardly in a component made from an Aluminium alloy (Fig. 3).

Fig. 3: Affected inner surface of the thimble.

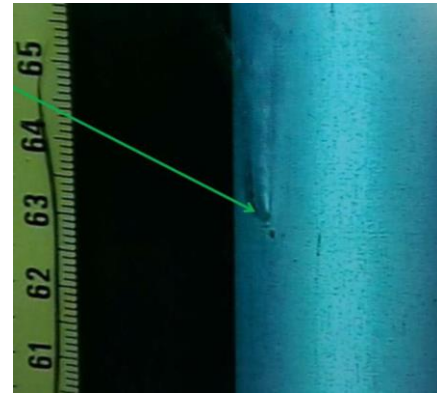
Final proof of a leak was achieved through an easy but effective test: the thimble was removed from the moderator tank and, still under water, a few mbar of air overpressure were applied. A string of bubbles (Fig. 4) lead to the faulty position which later could be linked to one of the affected spots identified earlier by endoscopic inspection. This test, although in general quite simple, required substantial and time consuming preparations: because the thimble had to be removed from the moderator tank, the heavy water had to be drained and subsequently the tank to be dried in order to avoid any further release of ^3H . This operation, although almost routinely done at the FRM II, takes several weeks to accomplish. A picture taken by the endoscope and the bubbles emanating from the tube are shown in Fig. 3 and Fig. 4 respectively.

Fig. 4: Air bubbles emanating from the thimble during application of slight overpressure.

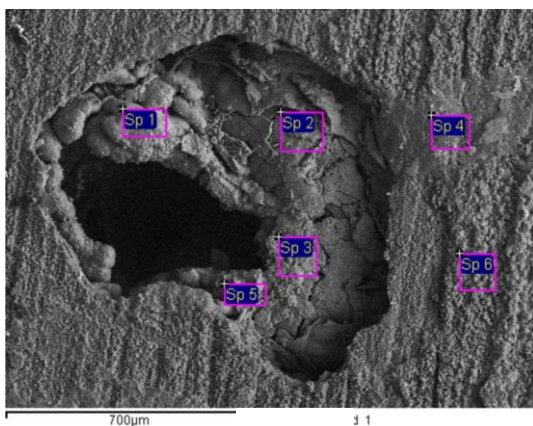
To verify that indeed the material AlMg3 (EN AW-5754) had been used for the bulk, stationary spark spectral analysis was performed. The composition of the material was clearly as expected. Also the overall granular structure met the expectations linked to AlMg3. At the affected positions, however, the situation was different: an EDX-analysis revealed clearly visible concentrations of Si, Cl, Cr, V, Mn and Fe (Fig. 5). It turned out that the black spots indeed were small cavernous holes with tungsten detectable on the surface. Outside the affected areas, unusual concentrations of materials foreign to the used alloy AlMg3 could be identified. Details of the analysis are shown in Tab 1.

Fig. 5: REM-EDX-Analysis of the outer surface. At the positions Sp 1 ... SP 6 the material composition was determined (cf. Tab 1) [2].

Tab 1 : EDX-analysis of surface contamination, all numbers given in weight-%, cf. Fig. 5 [2].

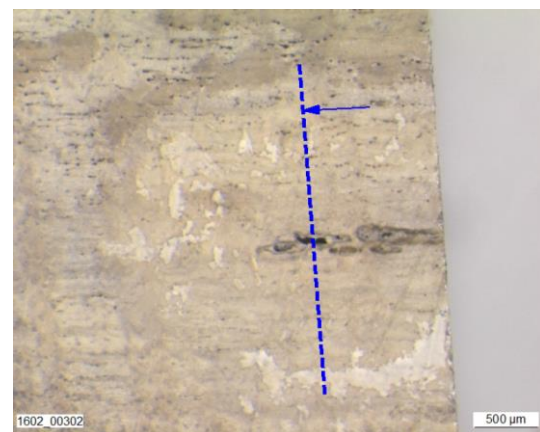
Fig. 6: Local indentations and indication of the position of a cut through the affected position [2].

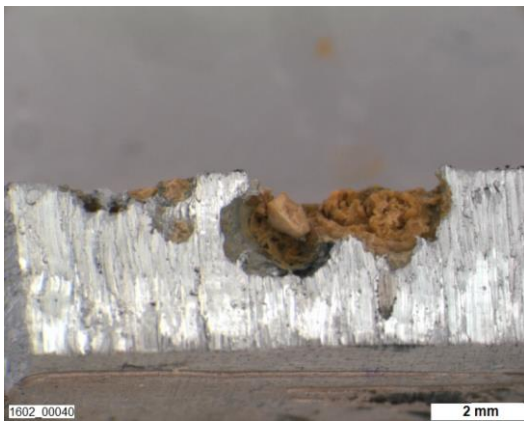
Fig. 7: Enlarged photo of a cut through a typical indication [2].

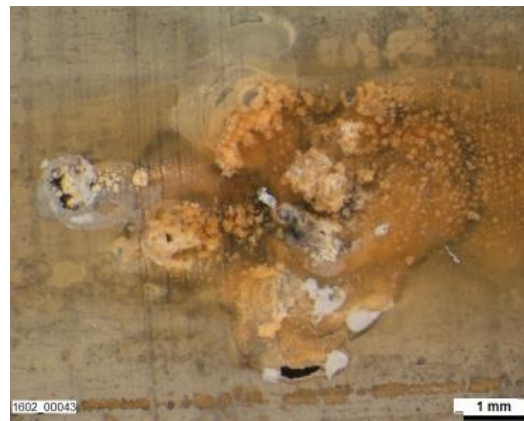
Fig. 8: Photograph of the inner surface in characteristic yellowish color [2].

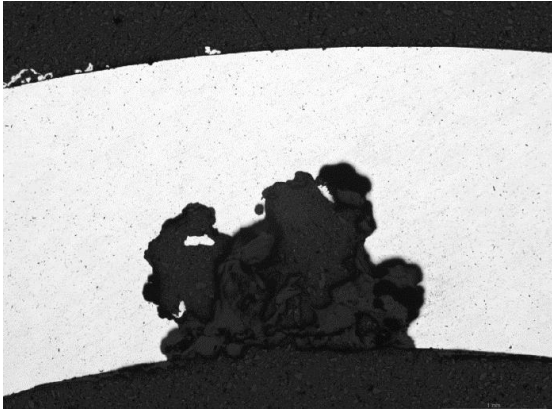
Metallographic analysis of a cut through the affected sample is shown in Fig. 9. In this figure, the thimble has been cut through one of the prominent black spots that had not yet led to a leak. The remaining wall thickness is about 2.8 mm.

Fig. 9: Metallography, cut through a “black spot” where the corrosion has not yet penetrated through the thimble. [2].

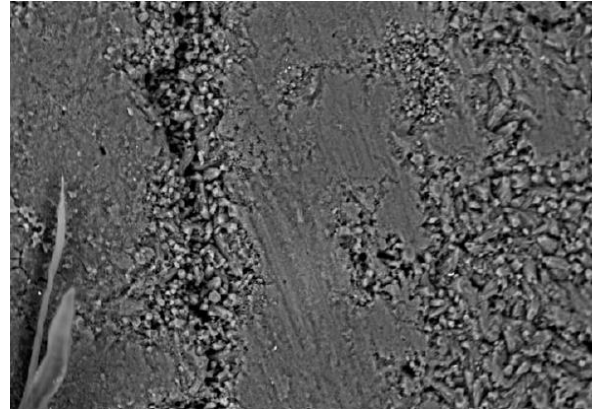
A complementary analysis of the affected thimble using gamma spectroscopy and REM-EDX has been carried out by RCM [3]. Striking is the quite different texture of the outer surface of the thimble compared to its inside. Pronounced granular structures mainly of Aluminiumoxide were found on the sample surfaces (Fig. 10). These are not typical for AlMg3 and considered as a hint of unusual corrosion. In the thimble containing the startup sources the surface fraction affected by this corrosion appeared to be smaller.

Fig. 10: REM-EDX image of the inner surface of the thimble (mag 928 x) [3].
