# TRACKING MICROBIOLOGICALLY INDUCED CORROSION IN A SPENT FUEL ELEMENTS STORAGE POOL

### E.M. LINARDI

Corrosion Department, National Atomic Energy Commission Av. Gral Paz 1499, B1650KNA – Argentina

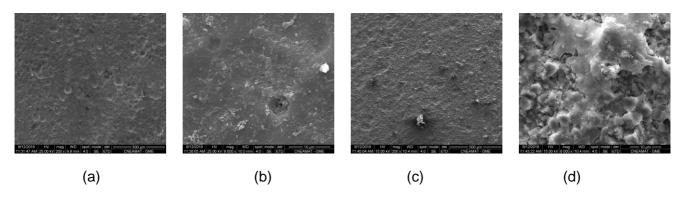
In all the analysed samples, images compatible with biofilms, bacteria and products of corrosion were observed (Fig 3). The presence of organic material was confirmed by EDX (data not shown). The samples showed zones covered by a black oxide with a higher biofilm content (Fig 3 c and d) and clear ones with a surface aspect similar to the appearence before exposure but covered with a thin biofilm (Fig 3 a and b). There were no differences between -8m and -15m.

Fig 3. Biofilms on AA 6061 coupons. (a-b)Clear zones. (c-d) Black oxide covered zones.

After 14-16 months of exposure, both corrosion products and biofilms were observed in the AA6061 coupons submerged at -8 and -15m. Two different zones were detected in the coupons: clear areas, with an aspect similar to the one before exposure, covered with thin biofilm and dark areas showing globular oxides associated with more compact biofilm patches. Under the patches images compatible with pitting corrosion induced by microorganisms were observed. No corrosion was detected after removing the biofilms and oxides from the clear zones.

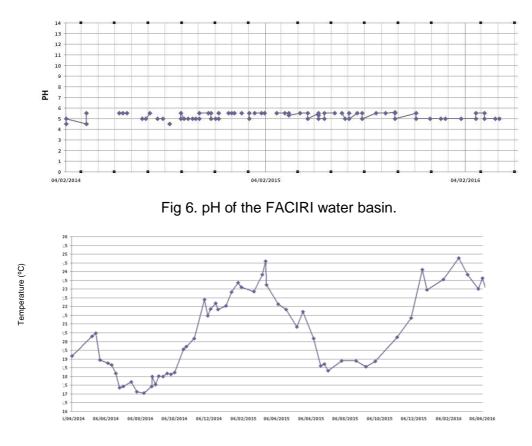
The conductivity of the water was usually less than 2  $\mu$ S/cm (Fig 5) which is in accordance with the operations manual of the facility. During this period of time, pH was between 5 and 5.5 (Fig 7.). Temperature showed fluctuations related to seasonal changes (Fig 8.) and there was a difference of 1°C between surface and -15m level.

Fig 7. Temperature of the FACIRI water basin.
