CORROSION SURVEILLANCE PROGRAMME OF SPENT MTR-TYPE FUEL ELEMENTS IN WET STORAGE SITES IN ARGENTINA

E. LINARDI, R. HADDAD

Corrosion Department, CNEA-CAC

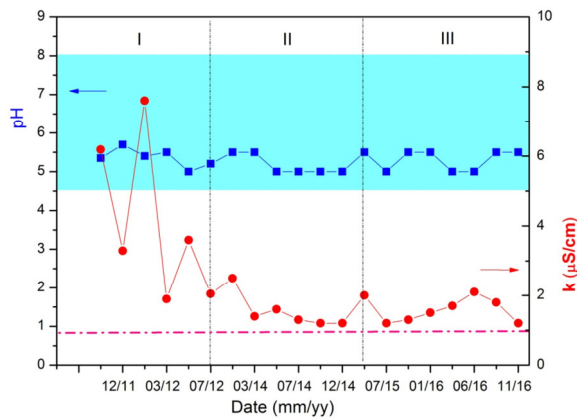
Fig. 9. RA1 reactor pool

The pH values recorded in all the sites were within the expected range, with the only exception of two points in the RA6 RP at the starting of the programme. From the analysis of the κ values in the RA1, it can be seen that at the beginning they were higher than the limit, reaching $\sim 7 \mu\text{S}/\text{cm}$, and then begun to decrease to values between $1\text{--}2 \mu\text{S}/\text{cm}$. The water in RA3 DP showed κ values also in the range $1\text{--}2 \mu\text{S}/\text{cm}$. For the RA6 facility, it can be seen that the conductivity in the decaying pool was always higher than in the reactor pool. This might be related to some lack of control in the decaying pool, unlike the water quality control performed in the reactor pool. It is again observed that the κ values are higher at the beginning of the monitoring.

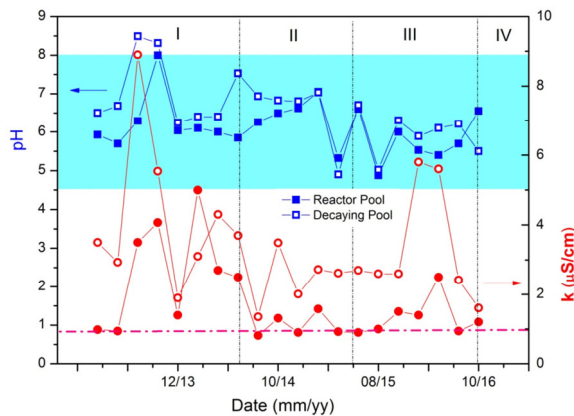
Fig. 11. RA6 reactor pool and decaying pool.

Coupon in Fig. 14 was exposed to RA6 RP water and coupon in Fig. 15 was immersed in RA6 DP in Period III. The main difference between the RP and DP water during that term was the conductivity value. Fig. 11 shows a higher k value in the decaying pool than in the reactor. This is likely to be the reason why the damage in DP coupon was more severe than

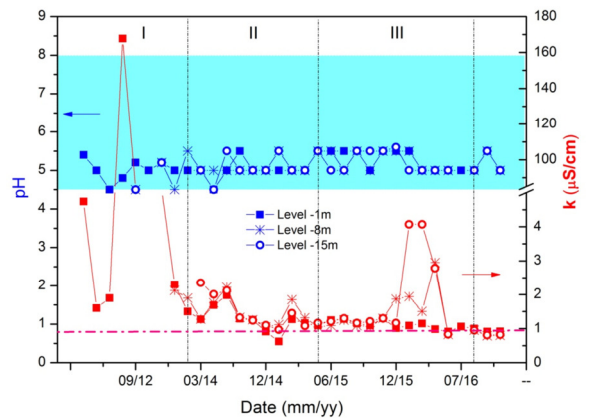
Fig. 12. FACIRI

In the case of the FACIRI, high water κ values were recorded at the beginning, which were attributed to the different operations carried out before the facility start-up. From Period II on, the water quality was improved, showing lower κ values, around $1\text{--}2 \mu\text{S}/\text{cm}$. Another characteristic that can be observed from the plot (Fig. 12) is the little variation in the κ and pH values among the three levels, except for a period beginning in December 2015. A rise in the κ values occurred in these period, mostly at the levels -8 m and -15 m. As discussed with the facility operators, this rise was coincident with the entry of new spent fuel elements. After that, the κ values in the three levels went back to $\sim 1 \mu\text{S}/\text{cm}$. The homogeneity in the κ values is an indication of the good performance of the water purification and recirculation systems of the facility.

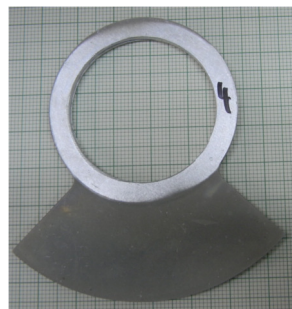
In the following section some examples of the coupons withdrawn from different sites are presented (all images correspond to the upward-facing side of the coupon). Fig. 13a presents one coupon that stayed 1 year in RA6 RP. A dark grey oxide is covering the whole surface of the coupon. A similar behaviour can be seen in Figs. 13b and 13c. This oxide growth is consistent with the water chemistry, the temperature and the fluid dynamics regime in the basins. This is generalized corrosion, and is not supposed to be a concern in spent fuel storage basins [4]. Some other coupons showed oxide in the surface but only in certain regions (Fig. 13d). As this kind of behaviour was observed only in the coupons installed in the FACIRI at the bottom of the pool (level -15 m), it was ascribed to the unique characteristics of the basin at that position.

Fig.13b. Coupon after Period II at RA3 DP.

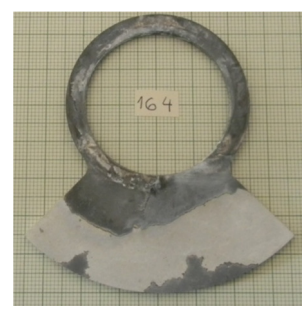
Fig.13d. Coupon after Period III at FACIRI (level -15m).

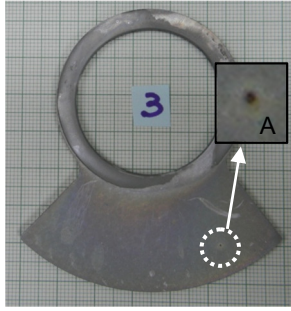
Another phenomenon frequently found in the coupons is the settlement of solid particles. In some cases, they are visible to the naked eye, such as the detail shown in Fig. 14. According to the test protocol for coupon analysis [3], the region with the particle is observed through OM, the surface is cleaned and observed again. Figs. 14b and 14c show the OM image of the particle “A” in Fig. 14 before and after the cleaning procedure. It is observed that the settlement of particles did not cause a severe damage in the material, just a shallow attack.

Fig. 14a: Coupon after Period III at RA6 RP.

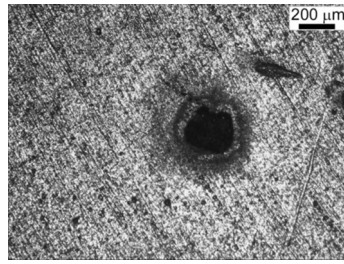
Fig. 14b: OM image of detail "A"

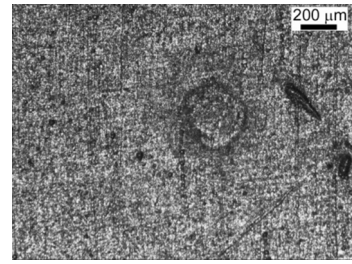
Fig. 14c: OM image "A" after cleaning

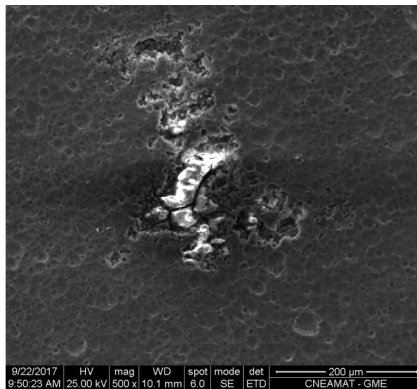
In other coupons analysed, the surface was covered with oxide and some settled particles surrounded by a stained region that seemed to propagate in radial direction around the particle, as shown in Figs. 15a and 15b. This was only found in the coupons exposed to the water in the RA6 DP during Period III. After cleaning the zone with the particles, it was found that the corrosion attack was more severe than in the prior example (Fig. 14). The images in Figs. 15c and 15d obtained by SEM (Scanning Electron Microscopy) clearly show that this kind of corrosion has produced dissolution of the metal matrix. Moreover, the morphology of this attack is similar to the pitting corrosion caused in aluminium in the presence of chloride ions [6].

Fig. 15c: SEM image of detail "B" after cleaning.

The type of corrosion described above is termed as under-deposit corrosion. It occurs by the settlement of solid particles (rust, cement, sand, etc.) and the extent of the attack depends both on the type of particle and on the conductivity of the aqueous environment [7].

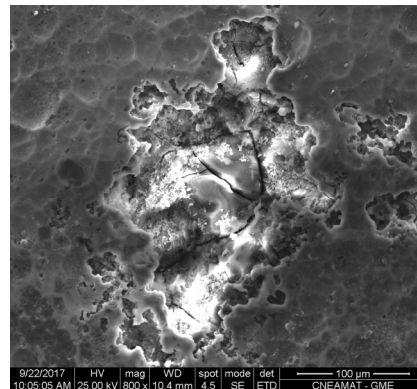
Fig. 15d: SEM image of detail "C" after cleaning.

in RP coupon. Even though there were settled particles in both coupons, the under-deposit corrosion mechanism was enhanced by a high conductivity. This fact shows a clear example of the effect that a slight rise in the conductivity water can cause in an aluminium plate.
