# ENUSA INTEGRAL SOLUTION FOR INTERGRANULAR STRESS CORROSION CRACKING ON EARLY 17X17 PWR DESIGNS

## ABSTRACT

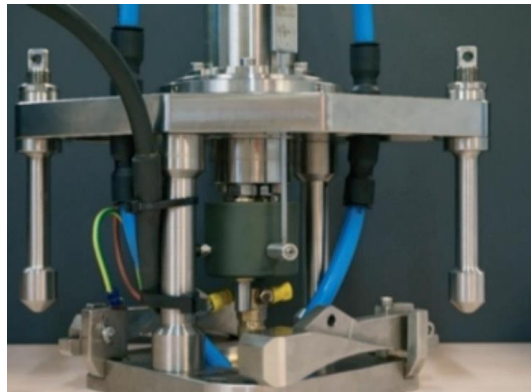
ESPIGA is installed into the fuel assembly following the next steps. First, in order to allow the installation of the device into the instrument tube, the top nozzle instrument tube plug is drilled. The diameter of this hole is slightly higher than the instrument tube diameter. The machining method used is electrical discharge machining (EDM), shown in Figure 4. The EDM equipment includes a suction system to remove the very fine particles produced during hole drilling.

Fig. 4. Electrical discharge machining (EDM) equipment, used to drill the top nozzle plate

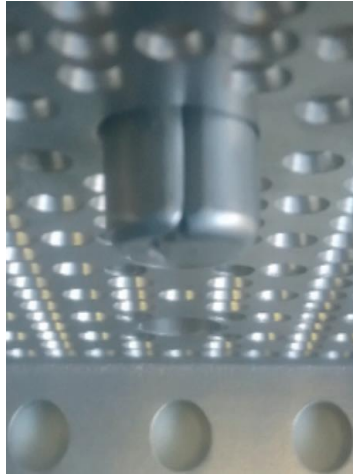
Once the hole is drilled, ESPIGA device is introduced through the instrument tube. For this step, the two rods of the device are positioned so that the inner rod is located inside the outer rod with the enlarged bottom ends aligned. When the device bottom ends are located below the bottom nozzle adapter plate, the rods are turned so that the bottom ends get a higher cross section (Figure 5).

Fig. 5. ESPIGA bottom end through the bottom nozzle plate at the instrumentation tube hole

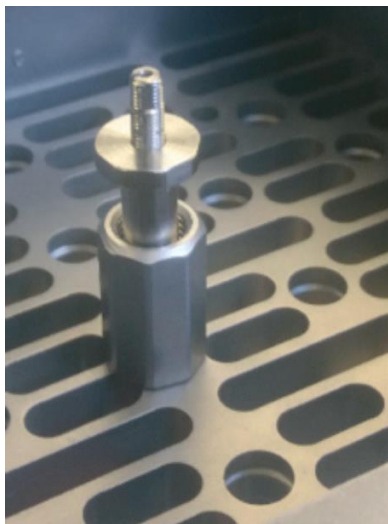
This relative positioning of the two rods is fixed with a nut. After that, the positioning of ESPIGA device against the fuel assembly is performed by lifting the device up to the bottom end is in contact with the bottom surface of the bottom nozzle. Then the second nut is turning against the top surface of the top nozzle as shown in Figure 6.

Fig. 6. ESPIGA top end on the top nozzle plate at the instrumentation tube location

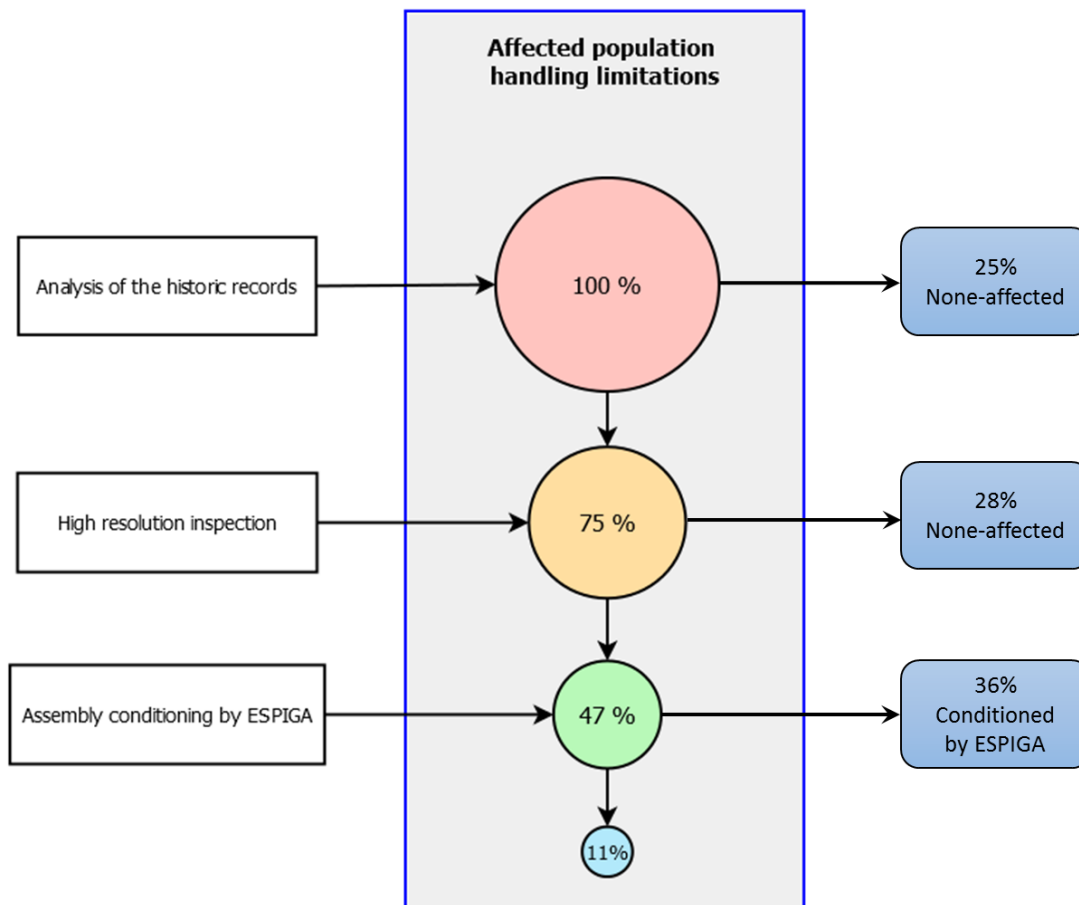
As a result of these actions, 89% of the initial susceptible population may be handled by normal means, dry stored and transported to the Spanish centralized interim storage facility (ATC). Altogether, the described actions conform an integral solution to the IGSCC issue, reducing significantly time and number of operations necessary for dry storage management. Figure 7 summarizes the reduction of the FA initial susceptible population after ENUSA actions completion.

Fig. 7. Effect of different actions on reduction of the initial susceptible population

- 25% were directly considered none affected by IGSCC and, subsequently, no special handling measures were necessary afterwards.
- 28% of the initial susceptible FA population had very low probability of being actually affected. High-resolution four faces inspection was recommended. In case of observing no corrosion indication, this population would be considered none-affected.
- For the remaining 47%, some of the FA can not be moved from their SFP location because they have shown clear corrosion indications during the visual inspections. For these FA, a conditioning solution was proposed and it is described later on in the manuscript.
