Handling, Transport and Program for Post-Irradiation Examination of Special Fuel Rods

Arno Benen¹, Andreas Hüttmann¹, Sten Lundberg¹,
Arnaud Cazalet², Joakim K.-H. Karlsson², Anders Puranen²,
Pia Tejlund², Charlotta Askeljung², Kyle Johnson² and Anna-Maria Alvarez²

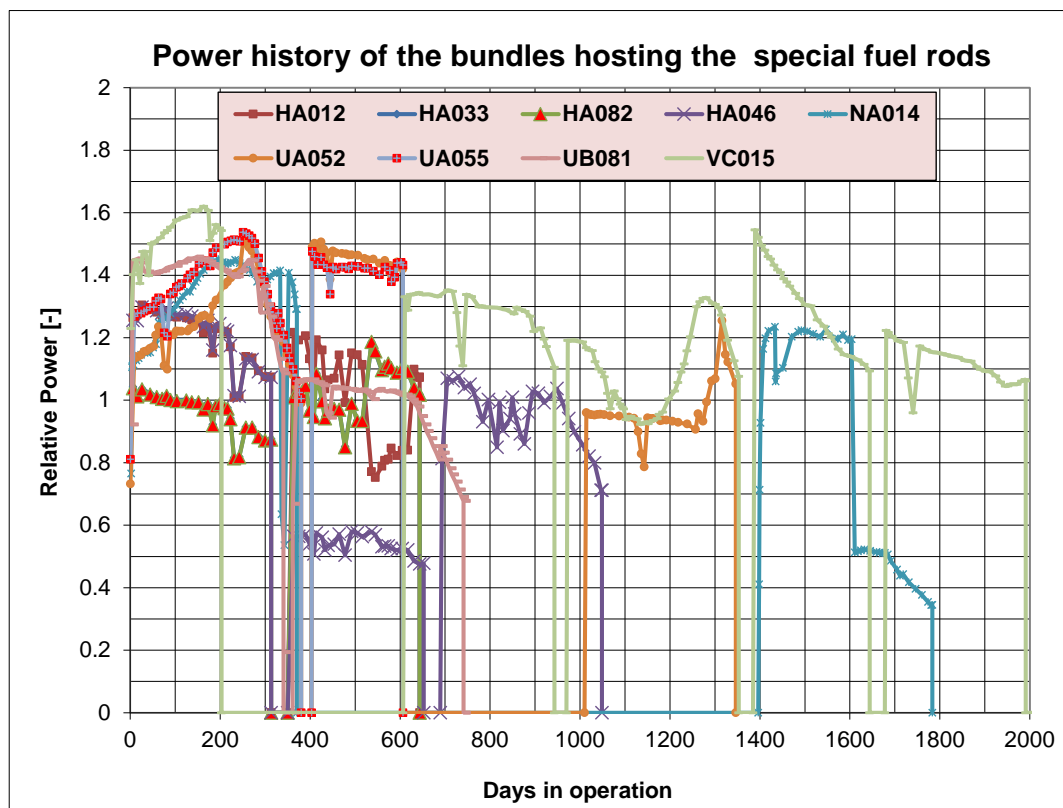
Fig 1 - Power histories of the hosting assemblies of the 13 Special Fuel Rods

The rod enrichments span over a range from 1.70 w/o up to 4.95 w/o. The irradiation time varies between two to six annual cycles and following a progressive In-Core-Fuel-Management (ICFM) by Vattenfall. The rod powers achieved were up to 420 W/cm compared to the allowed limit of 440 W/cm. The power histories of the 8 Fuel Assemblies (FA's) hosting the 13 rods are shown in Figure 1. For cycle 5 no data is available. The figure shows the span of the power levels over the cycles. The rod powers are very similar. With 49 kW/l the power density of the core is moderate.

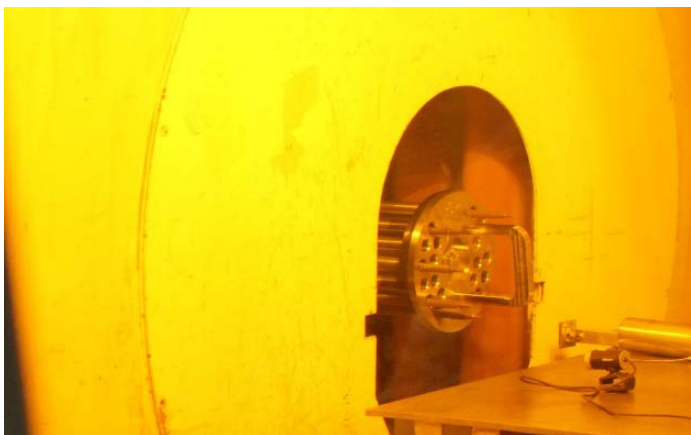
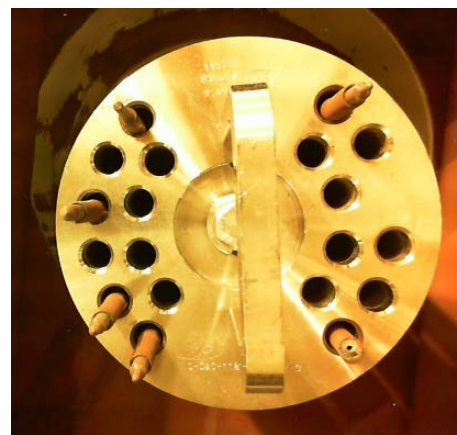
Fig 5 - The centering frame in the unloading position at the Studsvik hot cell and a front view the centering frame in the hot cell before retrieval of the rods

Each of three transports was safely received at the Studsvik hot cell facility in Sweden. Each transport was unloaded within a couple of days of arrival and the cask was then returned for the following shipment. As each rod was unloaded, the position in the centering frame and the identity of the rod was cross-checked and verified against the loading plan from KKB. This verification was performed and documented by two separate operators. A webcam located inside the hot cell was used to take photographs of the rod identification engravings on the bottom end plugs. Images were also taken of any areas on the rods which showed failures or were damaged or which showed features deemed interesting by the operators. The observations were also noted in the reception documentation. The rods were entered into the Studsvik inventory database and the Safe Guard database. Two pictures from the unloading of the first transport are shown in [Figure 5](#).
