FRM II: REPLACEMENT OF THIMBLES MADE FROM ALMG3 (EN AW-5754) FORMING A BARRIER BETWEEN HEAVY AND LIGHT WATER AFTER DETECTION OF CORROSION

Technische Universität München, Forschungsneutronenquelle Heinz Maier-Leibnitz (FRM II)

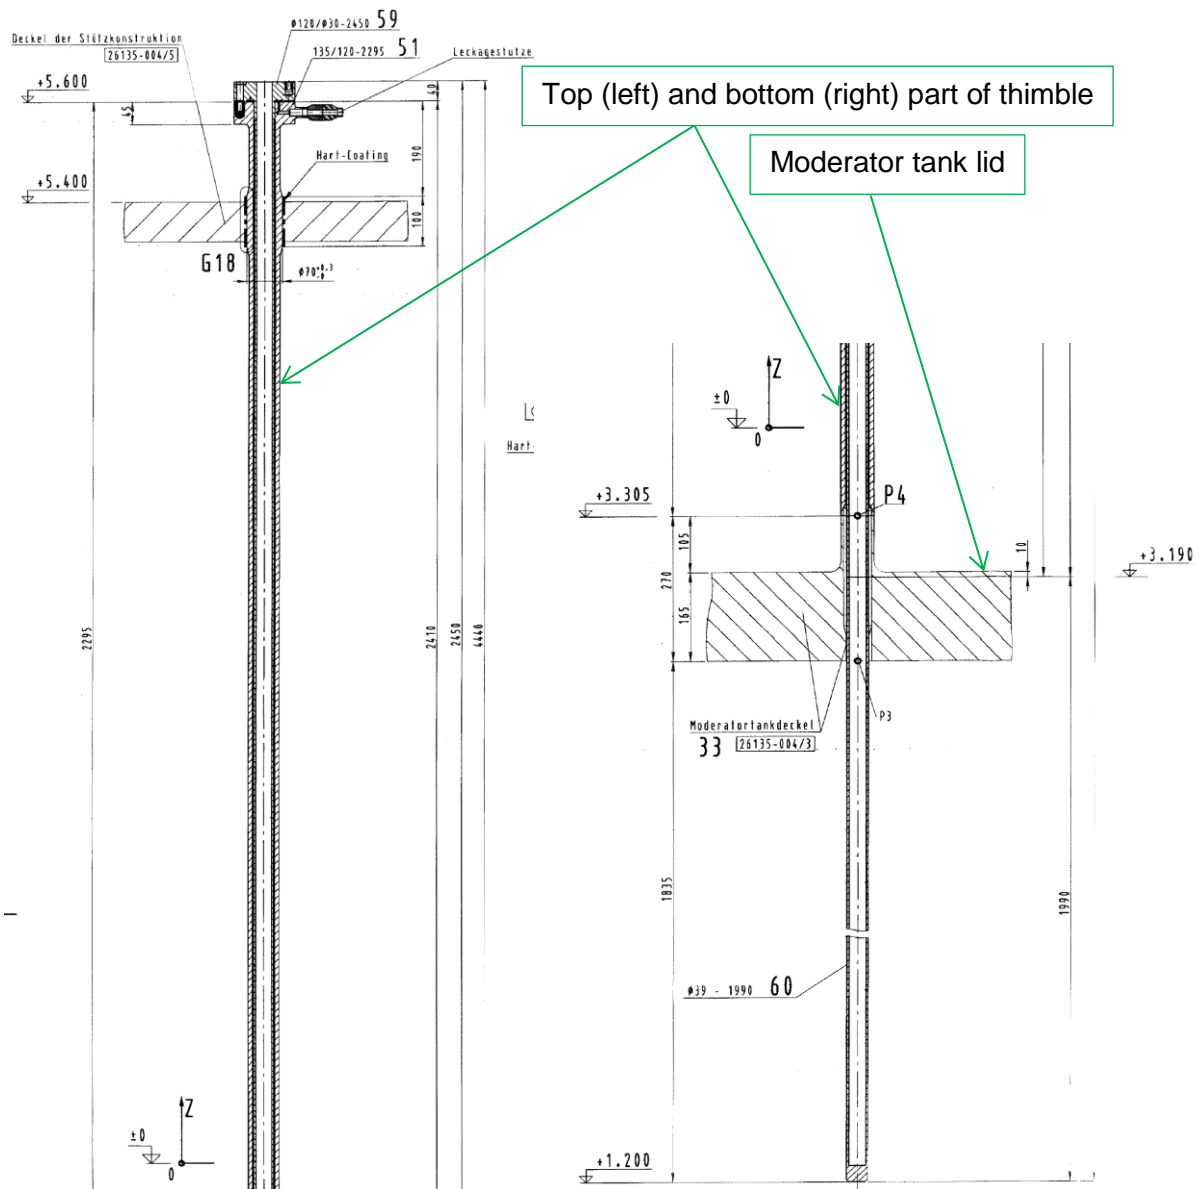
Fig. 2: Drawing of the thimble (left: top, right: bottom)

All four identical thimbles installed at the FRM II were inspected. Even though the three thimbles housing the thermocouples exhibited several of the same conspicuous spots as the one leaking no further leak could be found. In the thimble containing the start-up sources only very few of these spots could be found. As a precaution, it was decided to have new thimbles made to replace all four of the old ones.
