CORROSION SURVEILLANCE PROGRAMME OF SPENT MTR-TYPE FUEL ELEMENTS IN WET STORAGE SITES IN ARGENTINA

E. LINARDI, R. HADDAD

Corrosion Department, CNEA-CAC

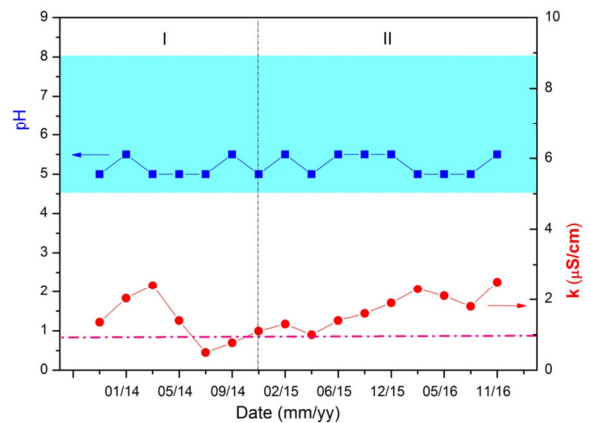
Fig. 10. RA3 decaying pool

The pH values recorded in all the sites were within the expected range, with the only exception of two points in the RA6 RP at the starting of the programme. From the analysis of the κ values in the RA1, it can be seen that at the beginning they were higher than the limit, reaching $\sim 7 \mu\text{S}/\text{cm}$, and then begun to decrease to values between $1\text{--}2 \mu\text{S}/\text{cm}$. The water in RA3 DP showed κ values also in the range $1\text{--}2 \mu\text{S}/\text{cm}$. For the RA6 facility, it can be seen that the conductivity in the decaying pool was always higher than in the reactor pool. This might be related to some lack of control in the decaying pool, unlike the water quality control performed in the reactor pool. It is again observed that the κ values are higher at the beginning of the monitoring.

According to the operators of the different sites, eventual increases in the k value have always been related to environmental factors, such as civil constructions in the surroundings of the basins, settlement of solid particles coming from debris, peeled paints, rust, etc.
